Field Survey on Historical Monuments for Assessment of Earthquake Resistant Structures: Case Study of Srinagar Capital City of Jammu & Kashmir, India

Index Terms - Historical monuments; Earthquake resistant features; Qualitative vulnerability assessment; Rapid inventory; Visual inspection.

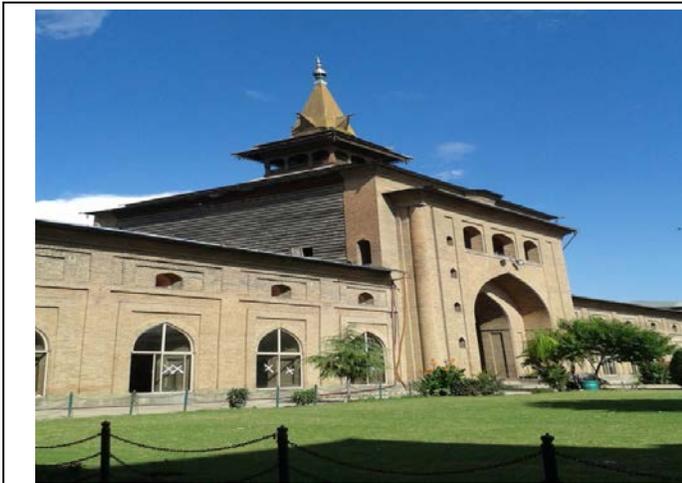
Figure 1

Jamia Masjid (Figure 1), the biggest Mosque in Kashmir, located in Nowhatta, is known as one of the sacred shrines of Islamic followers. The type of its architecture, its massiveness, complexity, size and perfection of design makes it one of the most extraordinary achievements of early Islamic art in the valley (Shali, 1993). The Jamia Masjid contains all the typical features of the Kashmiri wooden style. It was many times destroyed by fire, but was each time restored. The final reconstruction was effected by Aurangzeb who seems to have retained the original plan (Hasan 1974).

The mosque is a quadrangle and roughly square in plan, its northern and southern sides being 384 feet in length. Its principal features are the four minars, one in the middle of each side. They are covered by a series of pyramidal roofs, which terminate in an open turret crowned by a high pinnacle. The roof of each minar is supported on eight wooden columns, 50 feet in height and over 6 feet in girth, whose modern substitutes still stand on the original square limestone bases. The columns are plain and unornamented (Kak 2002). The main entrance is on the south side and consists of a recessed portico leading across the colonnade into the interior courtyard. A series of arched arcades with a clerestory goes round the courtyard, but in the centre of each side there is a square frontage containing an archway, while above it is the usual pyramidal roof and steeple (Hasan 1974).

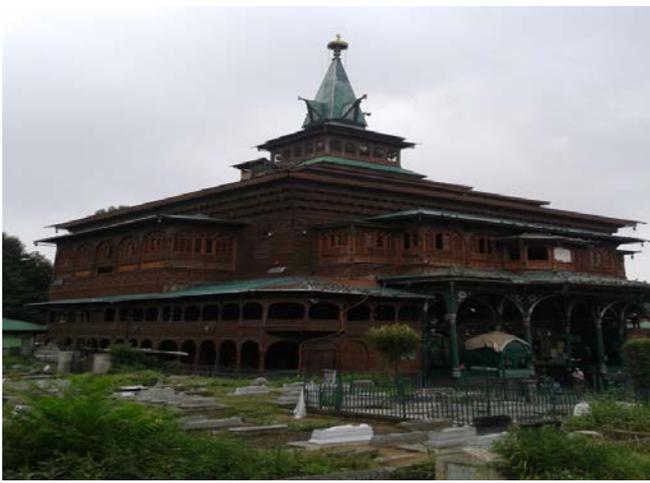
Figure 3

The shrine of Shah-e-Hamdan or Khanqah e Moula (Figure 3) is one of the oldest Muslim shrines in Kashmir situated on the banks of river Jehlum. It was the first mosque to be built in Srinagar and is a typical example of the wooden architecture of the Valley (Hasan 1974). The shrine was originally constructed by Sultan Sikander (1389-1413 AD) in 1395 A.D in the memory of Muslim preacher Mir Syed Ali Hamdani who is believed to be the main person behind the spread of Islam in Kashmir.

The shrine incorporates features of Buddhist, Hindu and Islamic architecture. The interiors of the building have beautiful paintings and carved woodwork. Antique chandeliers add to the beauty of the wooden structure. The mosque has its foundations composed of ancient temple materials. Barring its verandah extensions, it is in plan a square. Over it, the walls of the lower portion of the structure are formed of logs, trimmed square and then laid in alternate courses. The projections under the eaves are also of logs

laid crosswise. The superstructure also in wood is comparatively lighter and is represented by arcades, verandahs and porticos. The pyramidal roof crowning the whole structure is in three tiers and carries a distinctive style of its own. The entire roofing material now stands replaced covering the structure by corrugated tin sheets. The mosque of Shah Hamadan which is in three storeys, carries architectural embellishment in the interior of one of the only large hall on the ground floor as against the upper storey which is plain (Shali 1993).

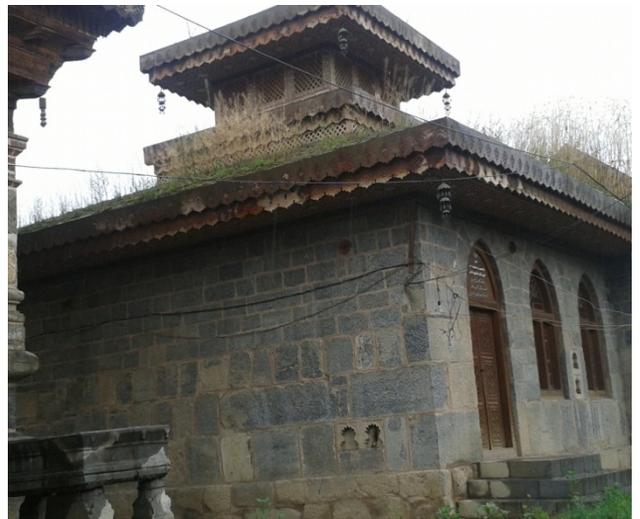
Figure 6

There are many inscriptions on the walls and lintels of the mosque, highlighting its period of construction and religiously important sermons. A carving showing a beast with the body of a leopard is adorned at the entrance. The tile work seen usually on masonry buildings in Kashmir is visible in the archway jambs. Both the tomb and the mosque were built in memory of the same person, and the inscription on the lintel of the entrance of the mosque records the date of its erection as 1483 A.D in the reign of Zain-ul-Abidin. The tomb may have been built a few years later, though it is not impossible that it was built at the same time as the mosque, for among Muslims the practice of building tombs during the lifetime of their future occupants is not uncommon. The inside view of the protecting structure of the tomb is shown in Figure 6.

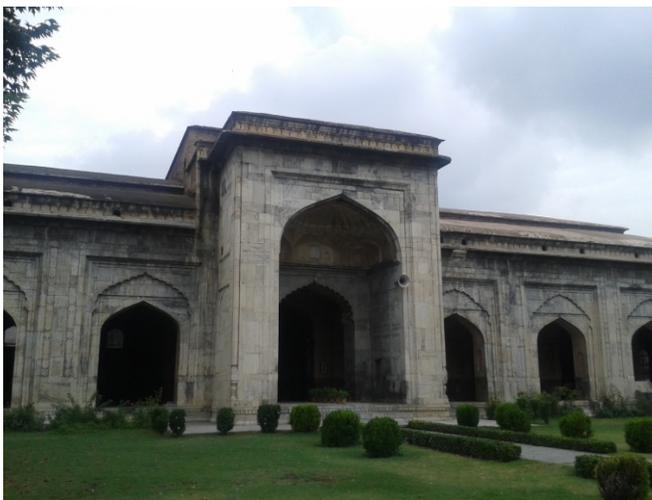
Figure 7

Patthar Masjid (literally Stone Mosque) located in Zaina-kadal (Figure 7), is the largest surviving example of Mughal architecture in Kashmir. It is very different to other monumental Srinagar mosques in both design and materials. This stone mosque of polished grey lime-stone built by Noor Jahan, the legendary beauty and wife of the fourth Mughal Emperor Jahangir, in 1623 A.D, consists of nine arches horizontally constructed. Soon after its completion, the mullas of Kashmir declared the mosque unfit for religious use and since then it remained isolated and now a preserved monument (Kaul 1971). It is believed that the construction was supervised by the renowned architect and a well-known Mughal historian Malik Hyder Chaudhary. The masjid is in ruins today and is of great interest to get a closer look at the Mughal architectural styles. There are nine horizontally constructed arches in the facade, the middle one being the largest arched portico (Kaul 1971).

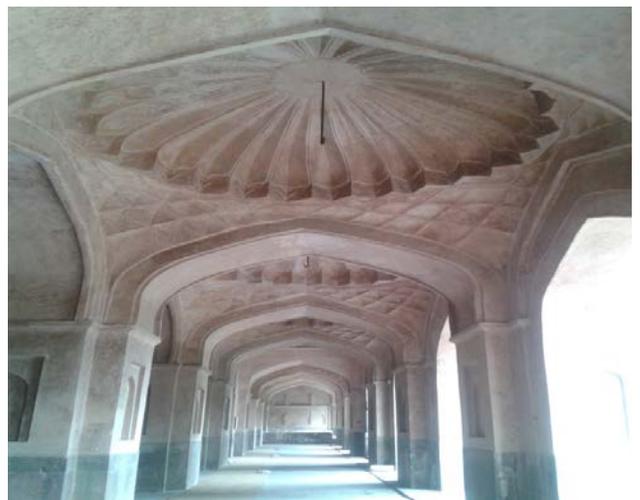
Figure 8

The inside view of the Patthar Masjid is shown in Figure 8. The arched openings are enclosed in shallow decorative cusped arches, which in turn are enclosed in rectangular frames. The horizontal construction of these arches is remarkable. All of them have recently been closed up with rubble stone masonry (Kak 2002). The visible coping stones of the now almost underground plinth have a series of large lotus leaves carved in relief and so have the portion of the walls between the projecting cornice and the eaves, some of which are also pierced. The roof consists of twenty-seven domes, the central one of which is the largest. The domes are mostly ribbed inside, though there are some which are flat. The roof is supported internally on eighteen extraordinarily massive square columns having projections on two sides. The lower portion of the columns is built of stone and the upper of brick covered by a thick coat of buff-colored lime plaster. The enclosure wall is built of brick masonry, with a coat of lime plaster, adorned by a range of shallow arched niches.

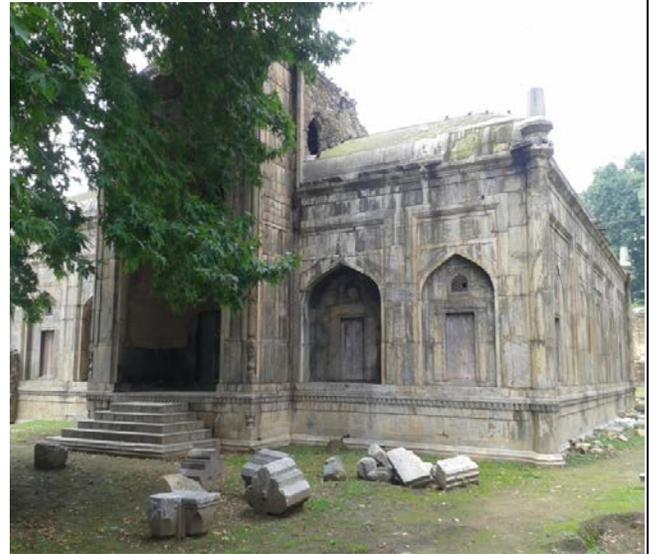
Figure 10

The mosque of Akhun Mull Shah (Figure 10) is located on the slope of Hari Parbat Hill and is a little way up above the Kathi Darwaza. It was built by Dara Shikoh, son of Shah Jahan, in 1649 A.D, for the use of his tutor, Akhun Mulla Shah (Kak 2002).

It is a unique structure built in stone rather than in wood. This small mosque is made of highly polished beautiful grey limestone. The mosque is the only surviving example in Kashmir which has intact the stone lotus finial over the pulpit. The facade has no decorations except the rectangular panels around the cusped arches. Its plan is rather singular. The small prayer hall, where pulpit stands, is flanked by two such chambers which are rather arcades on the two sides, while a similar arcaded chamber projected on the front serves as the gateway. Ruins of the arched halls on a lower level show them as lodgings for pilgrims. A Hammam, bath, is a little further off and has an inscription on the lintel of its doorway, giving in the chronogram of the last line the year Hijra, 1059 (1649 A.D.) as the date of the construction of the mosque and the hammam (Kaul 1971). The inner structure of the mosque has been rigorously inspected during the field to understand the structural design and set up of the mosque.

- The building material used includes stone, bricks (small kiln bricks) and red clay.
- The building is not in used and the structure is in a deteriorated condition.

- Due to rains few years ago, one side of the mosque got damaged and fell down but it was restored, suggesting lesser cohesiveness among the materials of the structure

- Renovation work is in process at present also in which the enclosing walls of the structure are being repaired and strengthened by providing them support with iron rods under the periodical retrofitting program of the structure with much lesser cost of expenditures than that of required for constructing new structures.
