# Assessment of Encroachment in the Rispna River of Dehra Dun City (Uttarakhand), India

**Key Words: Pollution, Consequences, Solid waste, Slum, Encroachment.**

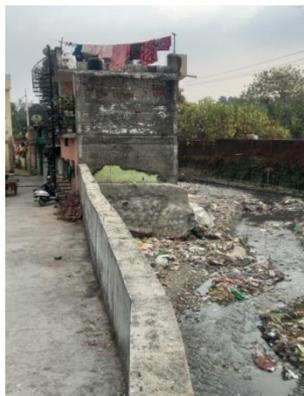
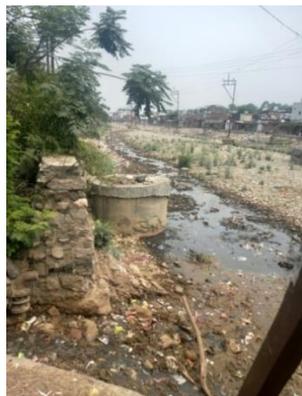
Fig. 6 and 7: Field photographs showing construction of building and sewage tank on the channel bed and Fig.8 showing evidence of dumping of domestic waste by the slum dwellers in the river .

rainwater (Photo Fig. 6). Due to the uneven drain condition, rainy water flows through streets and roads during the rainy season in the other residential areas which create pollution problems in the city. This cause choked drains, open garbage dumping, and mosquito menace problems. This health factor not only disturbed the slum people but also the nearer residents (Photo Fig 10). This problem can give rise to diseases such as poor productive health, lower energy levels, damaging central nervous function, and damage to blood composition, lungs, kidneys, liver, and other vital organs of the human body.

Another serious impact is the dumping of domestic solid waste in the riverbed (Photo Fig 7 and 8). Waste dumped in areas when not treated start smelling which causes the breeding of mosquitoes. These mosquitoes become the reason for diseases later on. Plastic dumped as waste cannot decompose but it choked the street drains and rivers. Plastic dumped as waste can be consumed by animals, resulting deaths of animals. The collected waste emits greenhouse gases, which increase the amount of carbon dioxide in the atmosphere, resulting in the warming of our environment. The result of this has come in the form of rising temperatures. The whole Rispna River in Dehra Dun is full of plastic and garbage waste by the slum dwellers. Plastic that is not decomposed releases a harmful chemical called Di Ethyl Hydroxyl Lamine which causes immense harm to human health. Somewhere slum dwellers burn the plastic and garbage waste in the channel bed. The smoke from the burning waste emits hazardous amounts of smoke into the air which leads to air pollution. The polluted air around the channel bed is responsible for various diseases such as asthma.

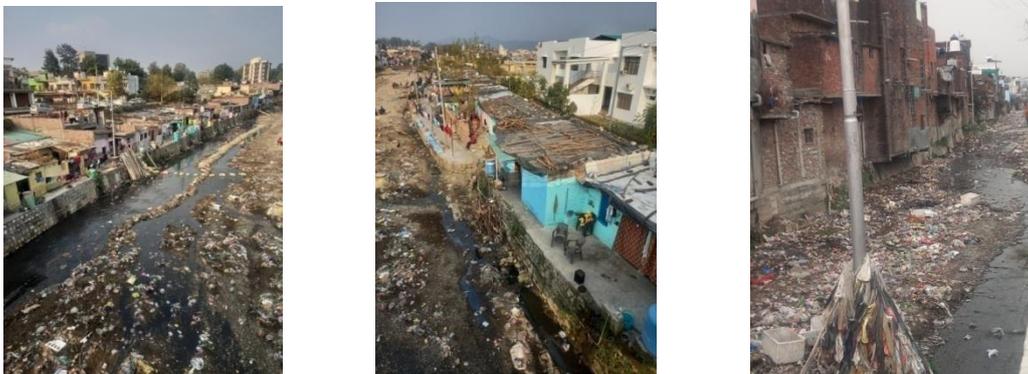
Fig. 9, 10 and 11: Field photograph showing series of slums both the bank of the Rispna river and pollution on the channel bed.

By 2022, the average width of the river has reduced to 19m (Table 1). The width of the river has reduced to less than 20 meters in about 7 wards (Table 3). In some places, the encroachment on both sides of the river has increased so much that the width of the river is less than 10 meters (Photo Fig. 6 and 11). It is a matter of great concern which needs urgent attention. Continuous increasing encroachment on the bed of rivers is a sign of danger for the future.
