Landuse Pattern of Neyyar River Basin (2015-2016), Kerala, India

Abstract- In order to understand the landuse pattern of Neyyar river basin, very extensive field investigation was conducted, and the findings were cartographically illustrated with the help of Geographic Information System (GIS), to provide an applicable outlook for a better landuse framing, as landuse has an inevitable role in the mere existence of the river. Geospatial pattern of the present landuse of the study area indicated that the sustainability of this river ecosystem is in danger due to unscientific landuse practices such as deforestation, reclamation of paddy fields, extensive rubber cultivation, sand mining, pollution and agglomerated settlements. The major landuse category observed in this region is settlement with mixed tree crops.

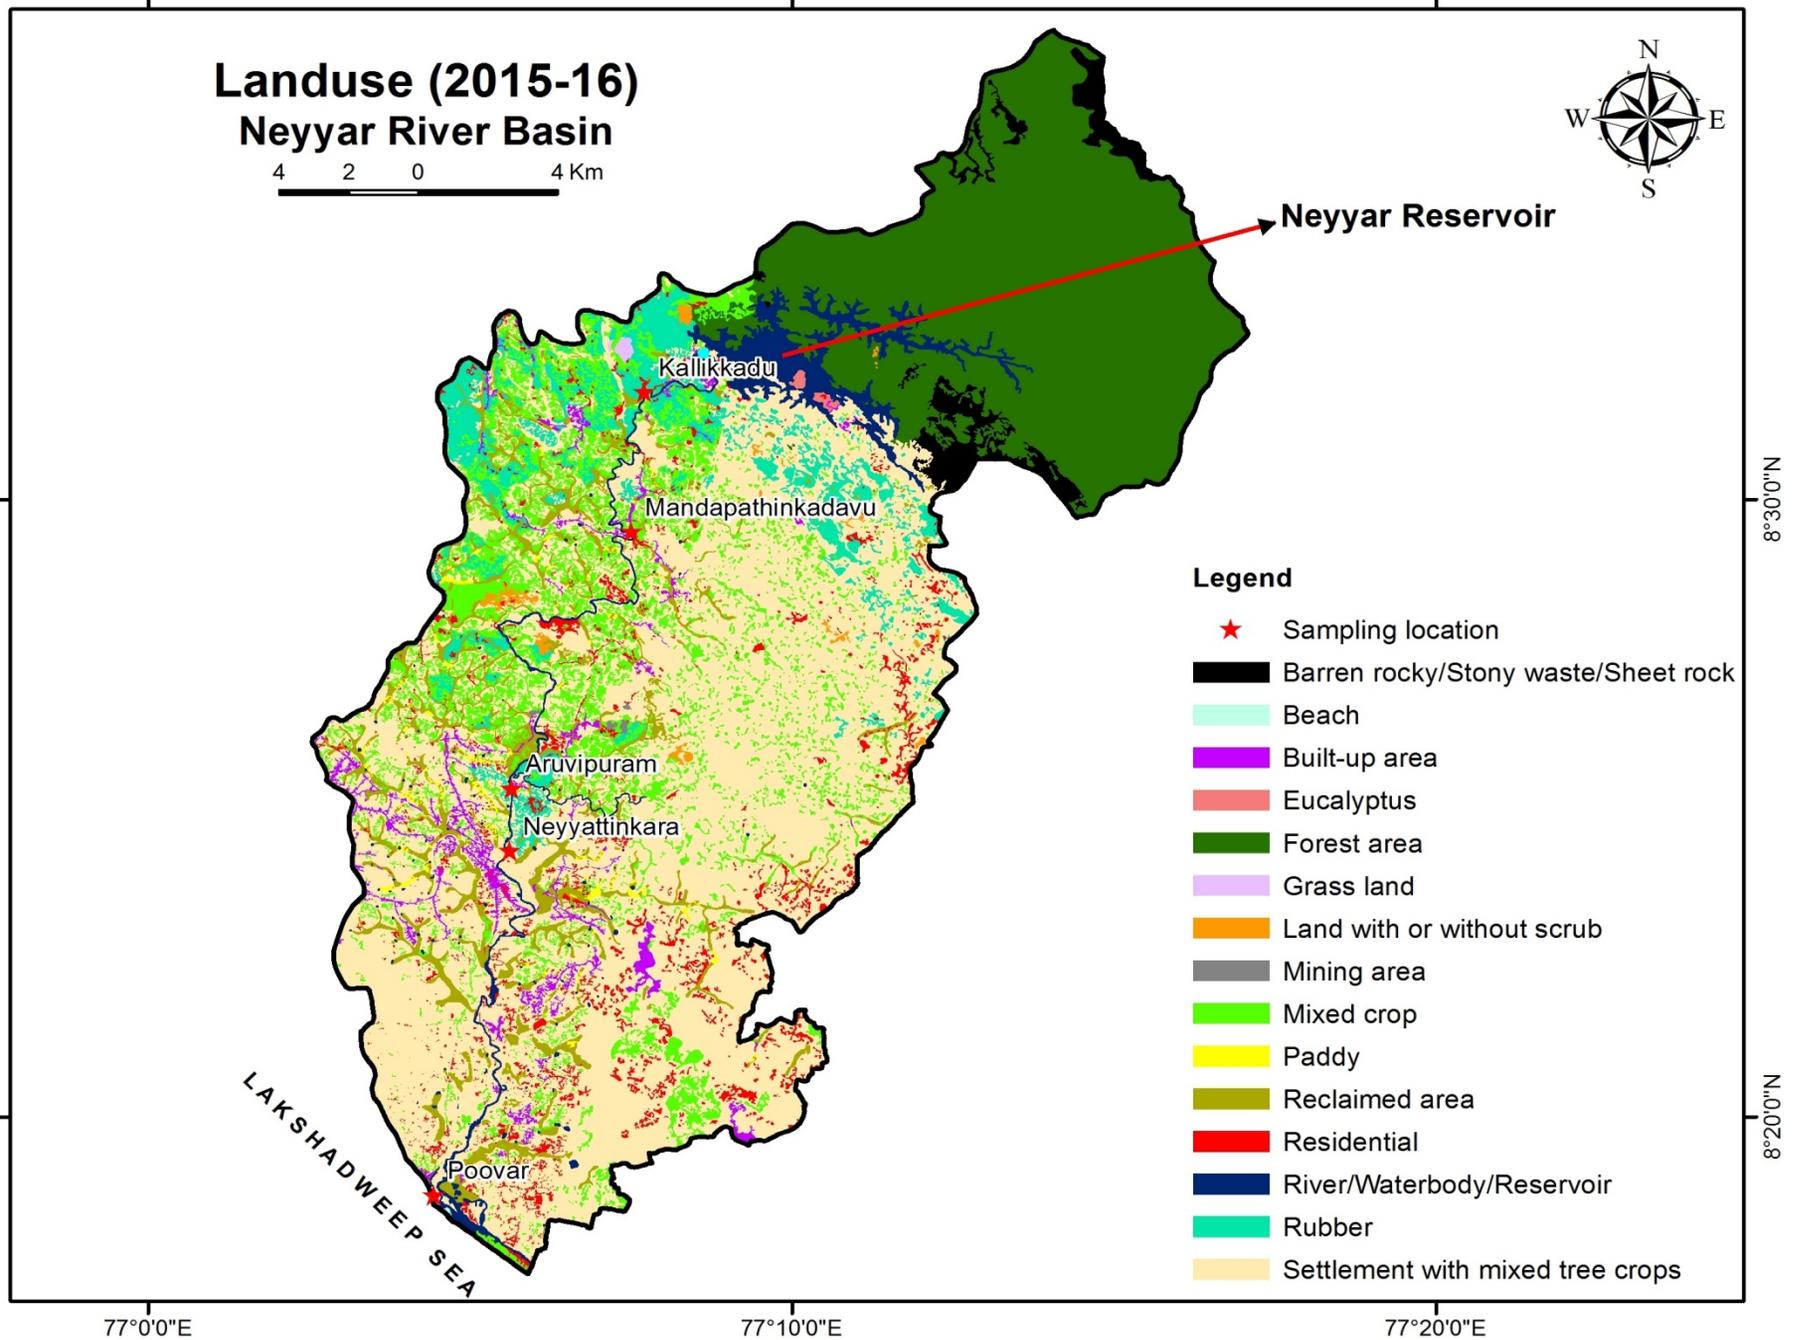
Fig 1: Landuse pattern of Neyyar River basin (2015-2016)

Mandapathinkadavu, Aruvipuram, Neyyattinkara and Poovar in particular. The sites are fixed representatively covering three physiographic components such as high land, mid land and low land. The current landuse pattern is input in the GIS software version Arc GIS 10.1 and a map is prepared. There are fourteen categories of landuse are designed in the map (Fig-1). The stream order map of Neyyar River basin was also prepared by using GIS (Fig-2). The latitude and longitude obtained by using Global Positioning System receiver was input in GIS for locating sites in the prepared map.

The landuse categories in Neyyar river basin mainly constitute forest area, mixed crop, settlement with mixed tree crops, built-up area and reclaimed area. The forest area includes dense forest, fairly dense forest, open forest, grassland, land with or without scrub and forest plantations such as eucalyptus, teak etc. The major landuse change observed in the forest area is deforestation and the cultivation of plantations. In Neyyar river basin the forest area is disperses in the highland physiographic region. The region well known for its biodiversity is under the verge of degradation. Forest fire and deforestation are the main threat for the biodiversity. Landslides and widening of river valleys due to physical weathering during the heavy rainy season are also common in the forest area.

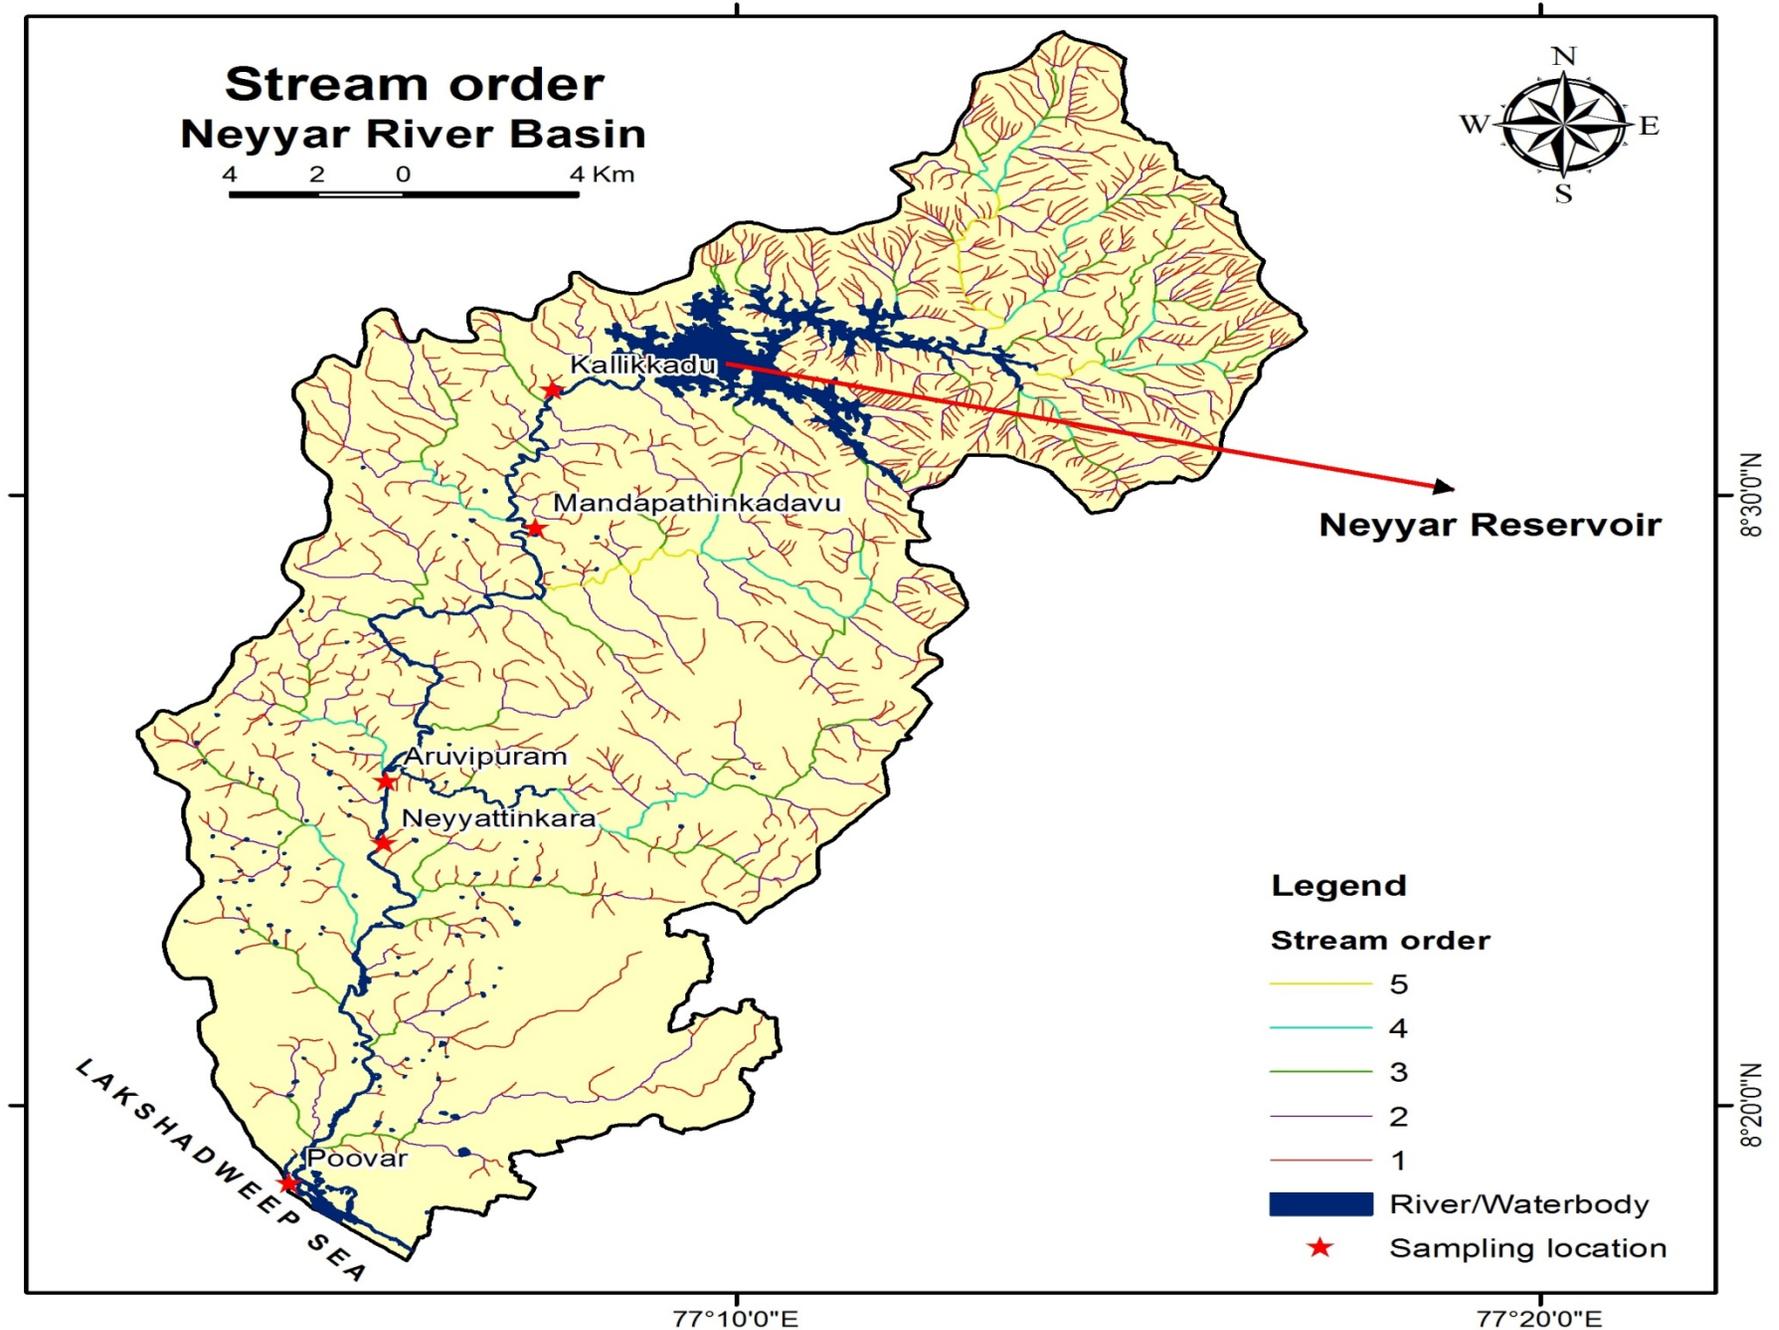
Fig 2: Stream order of Neyyar River basin

Due to the extensive reclamation in this area almost all the first order streams and few second order streams in the highland area below the Neyyar dam are reclaimed (Fig-2). Destruction of the basin through reclamation at the source itself is so distressing. This will adversely affect the biodiversity, sustainable ecosystem, and surface and groundwater resources of the entire basin as well. As paddy fields are well known as pollution sinks and media for filtering the ground and surface water, reclamation of them will have an adverse impact on the ecosystem. But due to the less population density, the fresh surface and groundwater in the highland is less polluted compared to midland and lowland. According to Bolstad and Swank, 1997; Liu *et al.*, 2000 and Tong and Chen, 2002, the landuse of high land especially forest area category is associated with minimal pollution threats.

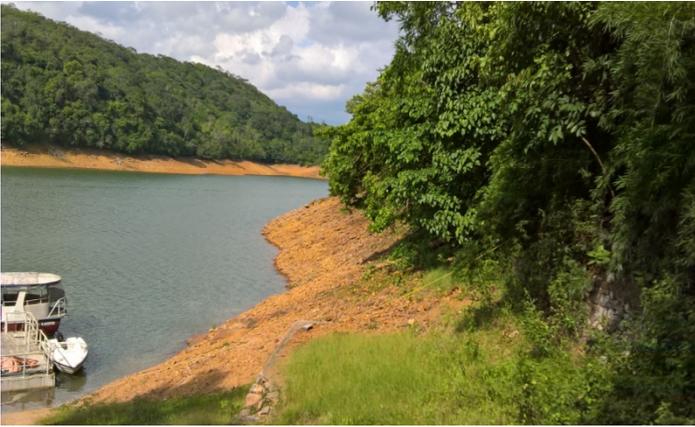
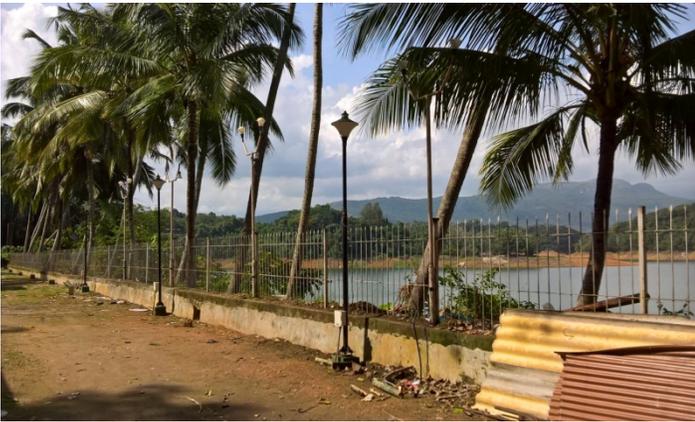
Plate 1 (a) Neyyar Reservoir

Plate 1 (b): Neyyar Reservoir

In Neyyar reservoir (Plate-1a&b), physiographically highland area mainly constitutes forest area, plantations including rubber, mixed crop and settlement with mixed crops. Extensive forest area can be seen at the upstream of the Neyyar basin and around the Neyyar reservoir as well. The forest area includes the dense forest, fairly dense forest, open forest, reserve forest, shrub forest, forest plantations etc. Deforestation and plantation of tree crops like eucalyptus and rubber is more common in this area. The widening of drainages is more evident in these areas due the erosion caused by huge amount of water flowing through drainage in rainy season. This storm water drainage within the forest area may cause not the destruction of forest only but also may trigger the landslides. Reclaimed paddy fields are occupied mainly by rubber. Bathing at the side of Neyyar dam and disposal of waste water including latrine waste directly into dam are noticed during our field visit, which is quite shocking and should be restricted.

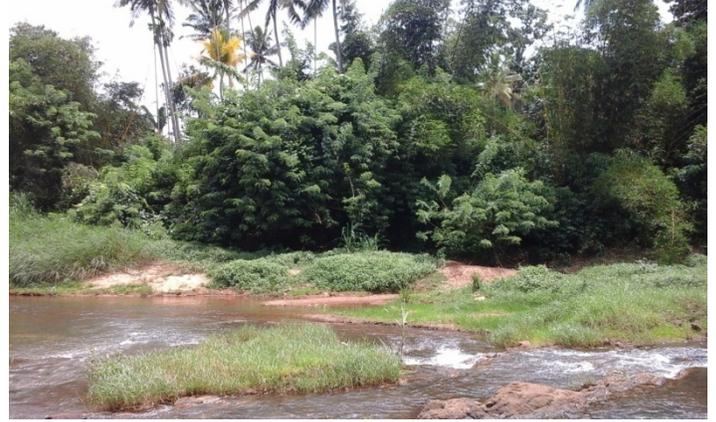
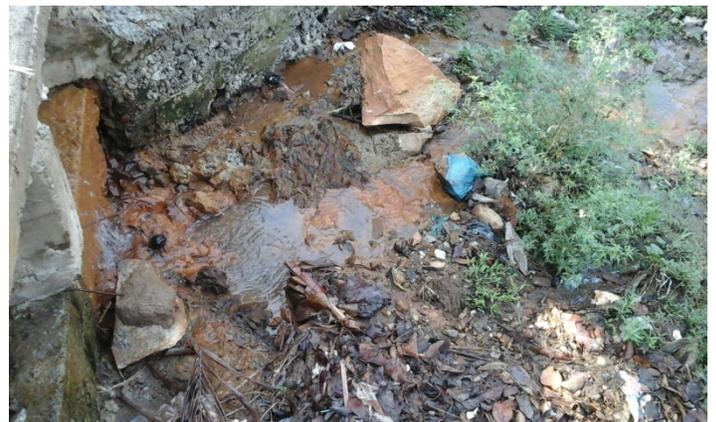
Plate 3 (a): Mandapathinkadavu

Plate 3 (b): Mandapathinkadavu

Mandapathinkadavu (Plate-3a&b) is located in transition area of highland and midland. Here reclamation of paddy fields is mainly concentrated in valley heads and near to the roads. The presence of paddy fields is more in the midlands compared to highland or low land. Banana and tapioca are the major crops in the reclaimed land. Drainage carrying waste water from the settlement of a micro watershed is directly debouching into the river site (Plate-3b). Construction of bunds at the site regulates river water flow. The major landuse categories at Mandapathinkadavu and surroundings are mixed crops including the tree crops, settlement with mixed tree crops, Banana, Tapioca, Rubber etc.

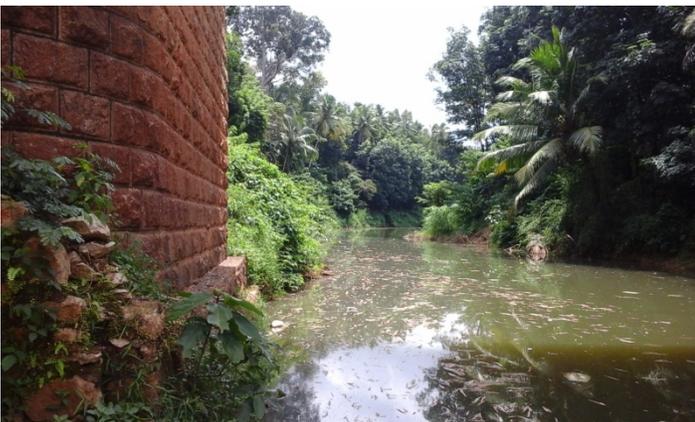
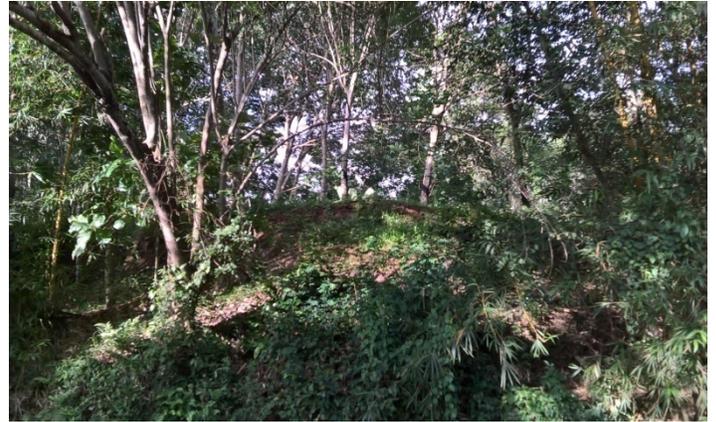
Plate 2 (b): Kallikadu

Plate 2 (a): Kallikadu

Kallikadu (Plate-2a&b) is located at the highland region with extensive rubber plantation. The reclaimed area in this region is mainly occupied by rubber plantation. Rubber extract lot of water from this reclaimed paddy area is the main reason for water shortage in the highland. This also contributes to enhance the pollution of water in the area. Prior to the reclamation the wetlands and paddy fields of highland and midland contribute as a fresh water resource to the low land. Water in this region is almost stagnant due to the extensive sand mining activities. As the site is located at fairly low population density area, the

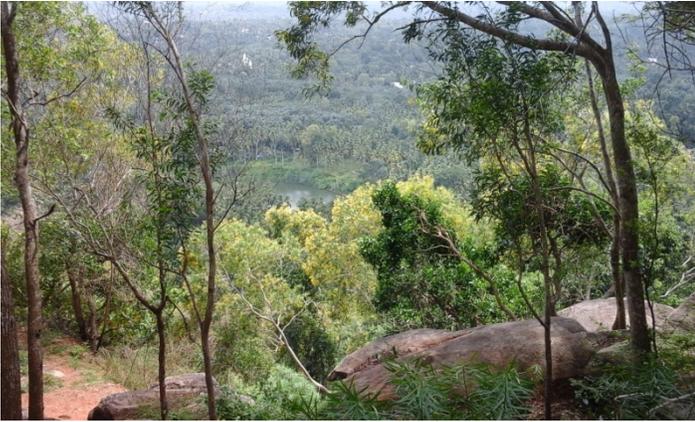
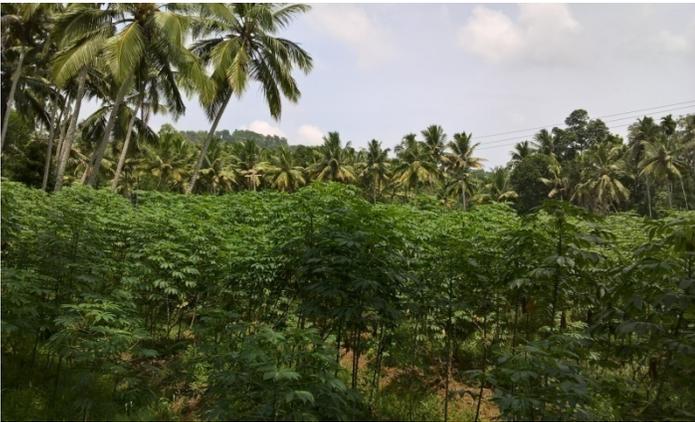
Plate 4 (a): Aruvipuram

Plate 4 (b): Aruvipuram

Deforestation and extensive cultivation of rubber plantation is observed at Aruvipuram area. The paddy reclamation is so intense and is mainly occupied by rubber. They are also occupied by crops such as banana, tapioca and the disperse presents of settlements (Plate-4a&b). The first and second order streams are being abandoned due to the crazy reclamation (Fig-2). The unscientific and extensive construction of bunds across the river is very common. All these factors will arrest the natural flow and self purification capacity of the river. Due to reclamation of wetlands, the extensive lateritic hillocks which are the major water holding formations are being derelicted in this region.

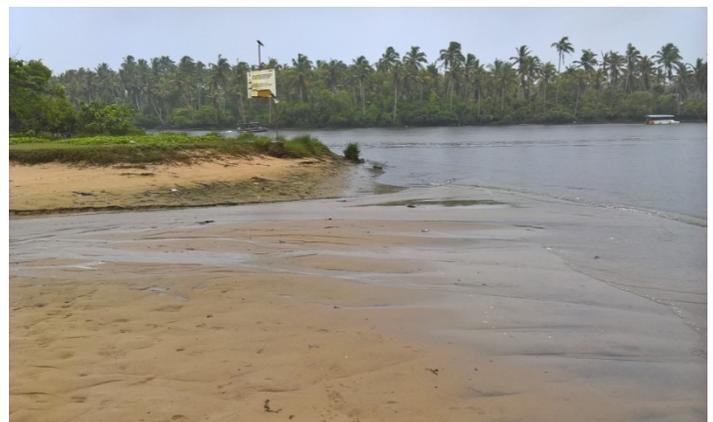
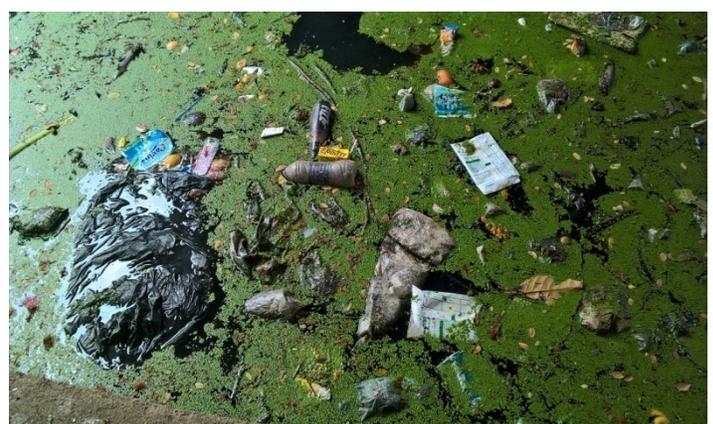
Plate 6 (a): Poovar

Plate 6 (b): Poovar

course of the river has become water logged, marshy land especially in the area from Thirupuram to Poovar. Poovar is located near the Coast of Lakshadweep Sea where the river water is stagnant. The water is highly polluted (Plate-6a&b). All the pollutants from the upstream are concentrated in this region. The major landuse around this area is coconut plantation with mixed tree crops.

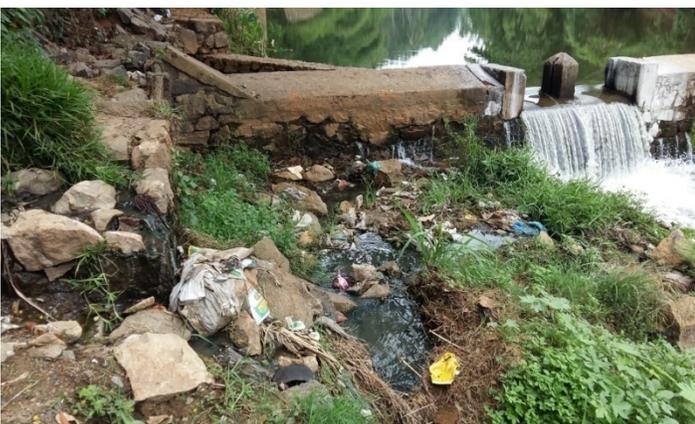
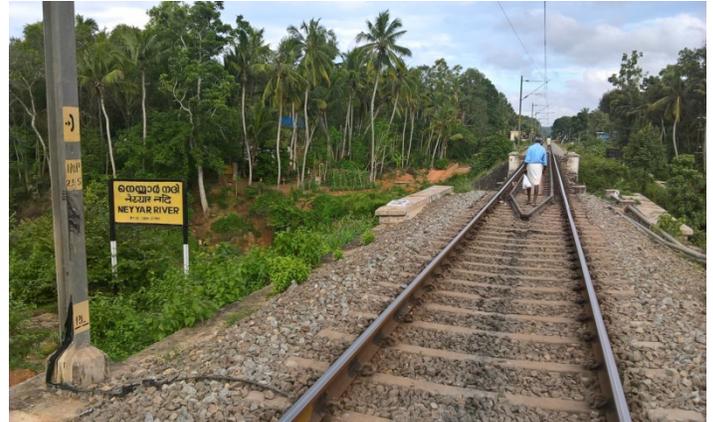
Plate 5 (b): Neyyattinkara

Plate 5 (a): Neyyattinkara

The province at Neyyattinkara, located at the lowland area is a municipal region. Due to the presence of the agglomerated settlement and industrial effluence, the site is highly polluted (Plate-5a&b). The constructions of bunds across the river in this region arrest the self purification capacity of the river and thereby enhance its pollution. It is not advisable to build the bunds across the river at the low land where the stream flow will be minimal compared to highland and midland. Consequent to such arrest in the water flow, concentration of pollutants in surface and groundwater may take place. The major landuse category in this region is settlement with mixed tree crops. Paddy and wetland reclamations are most common in this region. The reclaimed area is mainly occupied by banana, tapioca and mixed crops. The residential and other build up areas on reclaimed paddy fields and wetlands are very intense compared to that of Aruvipuram.
