# The impact of SWC measures on social, environmental and economic aspects in Mizraf watershed in Tigray

**Abstract-** The general objective of the research was to assess the impact of SWC measures on social, environmental, and economic aspects in Mizraf watershed in Tigray, Northern Ethiopia. Data were collected through semi-structured interviews, transect walks, field observation and field measurements demonstrated that Degradation Status after implementation of SWC highly reduced & all most 80% of it was reclaimed. The results of the positive impact of SWC measures implemented in this watershed were. The gully depth averagely reduced to 1m deep & it is all most dead (reclaimed). New spring water developed its discharge was measured 42.3 lit per second and the tunneling, rill, and sheet erosions are ceased out and this contributed to land productivity. However, some of the check dams constructed in both the upstream and downstream parts of the landscape collapsed due to faulty construction, and the Bureau of Agriculture as well as the Food for Work campaign program coordinators did not give enough follow-up and monitoring of check dam maintenance.

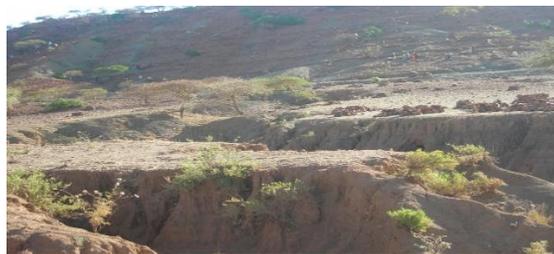
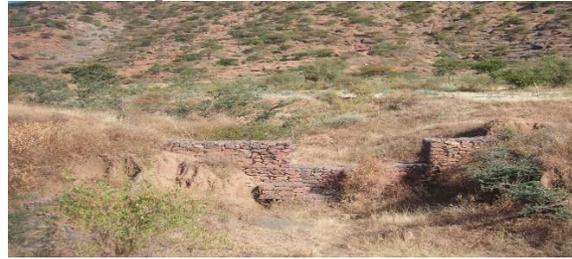
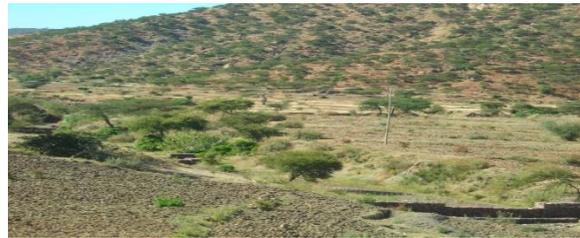
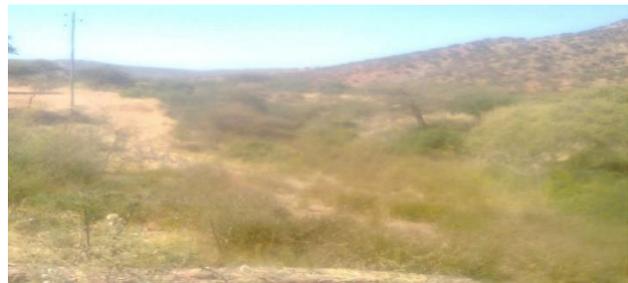
Figure 1: The impact of SWC measures on gully reclamation (Photo A, B, C)

A) The photo was taken in Dec. 2009

B) The photo was taken in Dec. 2011

C) The photo was taken in September 2019.

Sample photo that shows comparing and contrasting the previous and present status of the gully and the gabion check dams are filled with sediments and covered by biological plants like vetiver grass, elephant grasses.

In the above consecutive pictures illustrating different photos taken at different times. As it is observed, the big stone taken as a reference frame is now covered with forests. And the area is showing the gradual change from time to time.

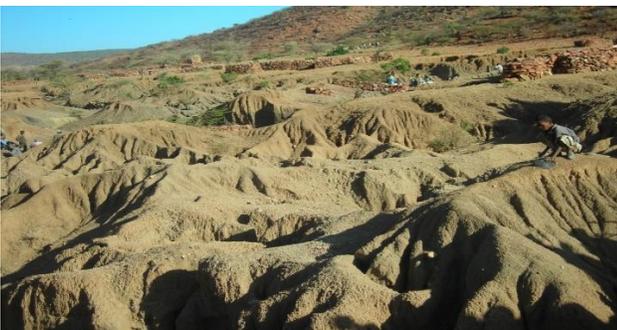
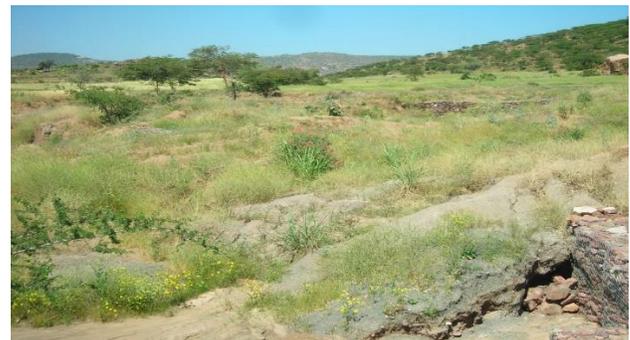
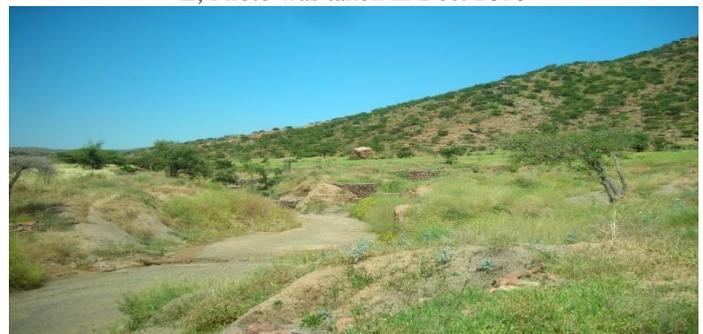
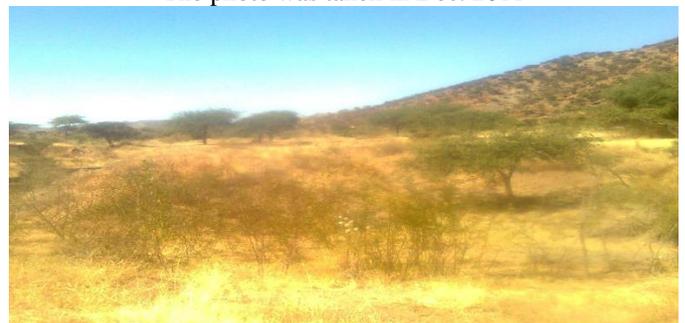
### Figure 3 Degradation Status before and after implementation (D, E, F)

D, The photo was taken in September 2008 before implementation

E, Photo was taken in Dec. 2010

The photo was taken in Dec. 2011

F, Photo was taken in Dec. 2011

The above photo shows before the implementation of SWC activities, there was a big degradation process. That is the cultivated land was fragmented into different segments and it was very difficult to perform activities such as cultivating the land, crossing the gully for both the animals and even for human beings. But now different gabion check dams (i.e. about 16) and loose rock check dams (about 9) were constructed and integrated with different biological conservations. Therefore; the degradation status is now reduced by more than 75% and almost the gully is reclaimed (relieved).

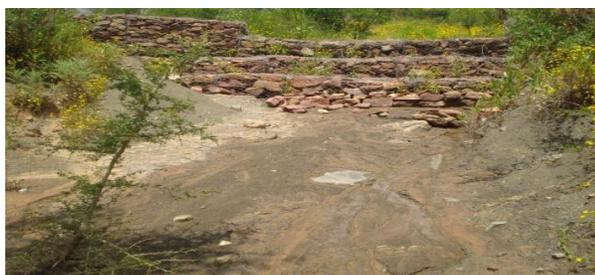
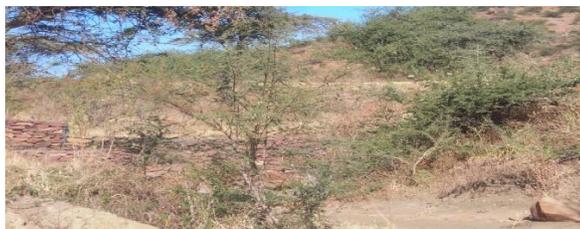
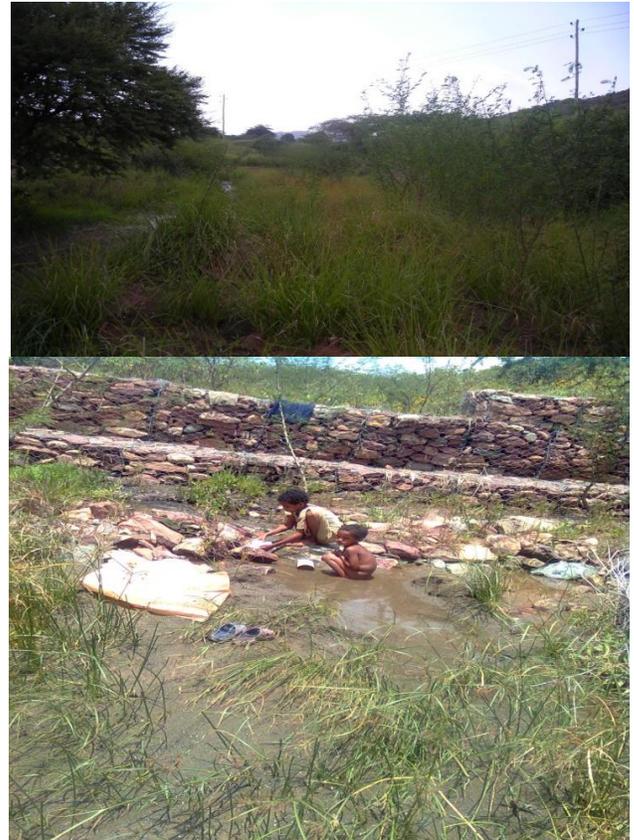
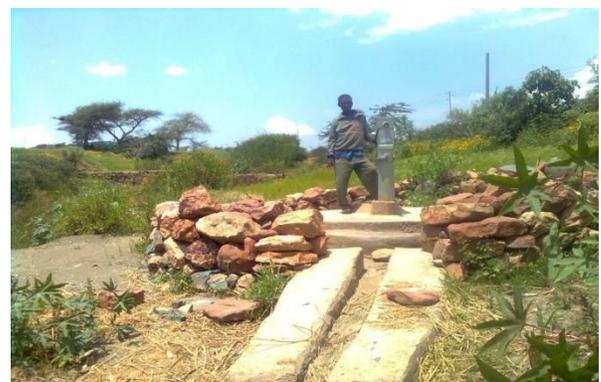
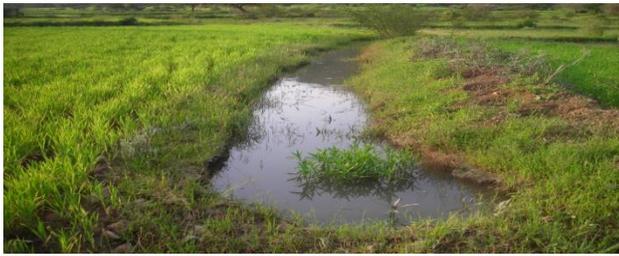
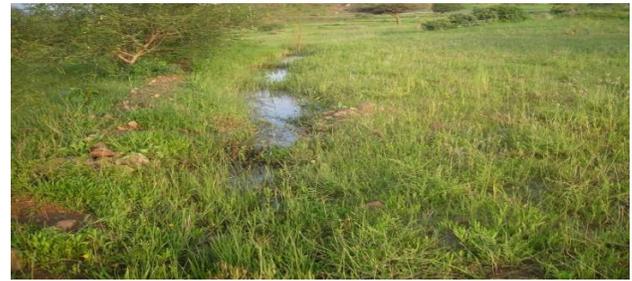
**Figure 4, Spring source Status before and after implementation**

The photo was taken in October 2009

On the contrary; after the implementation of different techniques of soil and water conservations on the catchment treatments and gully reclamations integrated with biological soil and water conservation was done; the groundwater table of the hillside area is recharged. And the water sprouts out as spring and

new spring water developed. And its discharge was measured **42.3 lit** per second water was measured on September 27, 2011. and this water stays till **December** regularly running and on some parts of the gully as pond form ponded till **June**. It is easy to compare the two photographs taken in different years, the previous one is dry and the plantation of the biological plants very young. While the recent one with matured biological and spring developed.

This shows children washing their body from the spring developed and hand pump photo at the downstream. Deep trench Photo taken in September 15/2011 & seasonal spring developed

Photo: demonstrating water status at the downstream

Before the intervention of the project soil and water conservation, the gully was completely dry. And the top part of the soil that is very important and fertile for crop production was completely eroded. Hence, the bed of the gully was left with a hard internal argillaceous black rocky structure that looks hard and smooth during the rainy season but during the dry season it fractures from time to time, and while the heat of the sun in the day time and cooled condition during the night varies it easily weathered. Therefore; the bed of the gully breaks down and it was aggravating degradation. As can be observed from the photo below.

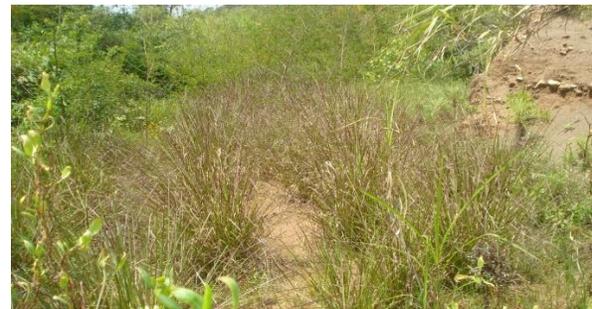
The photo was taken:- in September 20/2009, gabion check

The photo was taken:- in September 26/2011

As it is observed in the above table, many parts of the gully are all most filled. The average gully depth is changed from 4 m to 1m (i.e the difference of two meters is filled with soil that comes via the flood). But on some specific areas/parts/ of the gully there are all most 100% reclaimed. The total area of the gully is about 0.78ha and this all is serving as a source of forage production to the animals (no any part of the gully is free).

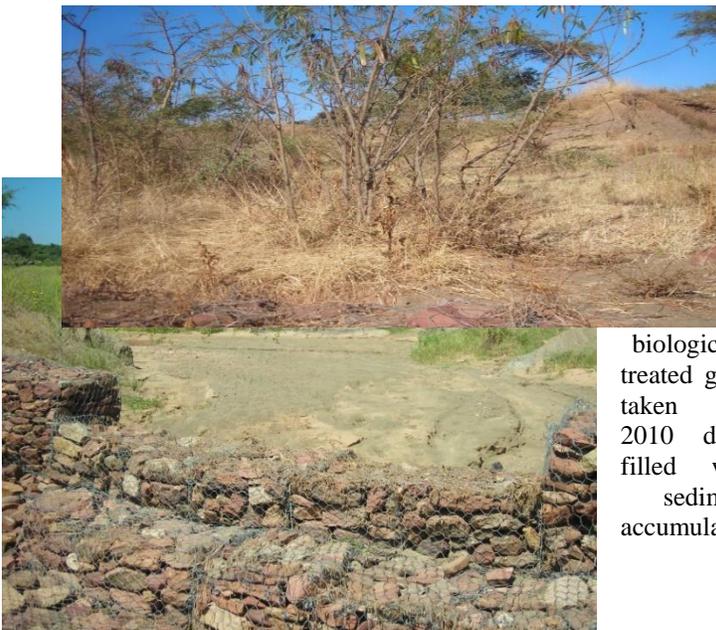
biologically treated gully taken in 2010 dams filled with sediment accumulated

implementation of integrated SWC activities emphasized biological plantation practiced  
Photo Status of gull in the cultivated land                      Seasonal spring water developed at the cultivated land

As it is observed from the above photos, the rain is highly harvested and left on the ground. These types of techniques and others like percolation ponds, deep trenches, simple trenches, hillside terraces, e.t.c. retained the water that comes from the upper catchment and reduces the runoff that aggravates degradation. Hence, in turn, reduces degradation and results in land stability, sprig development as seen in different photos under different subheadings.

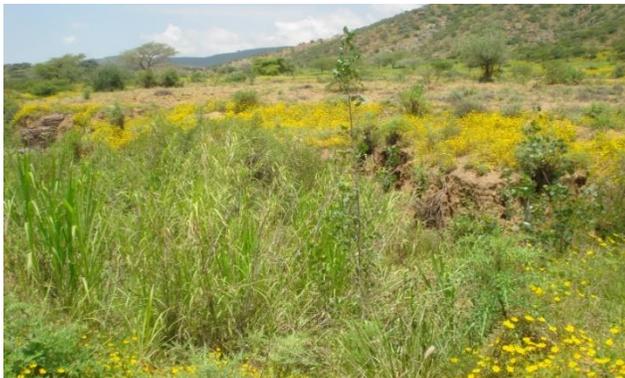
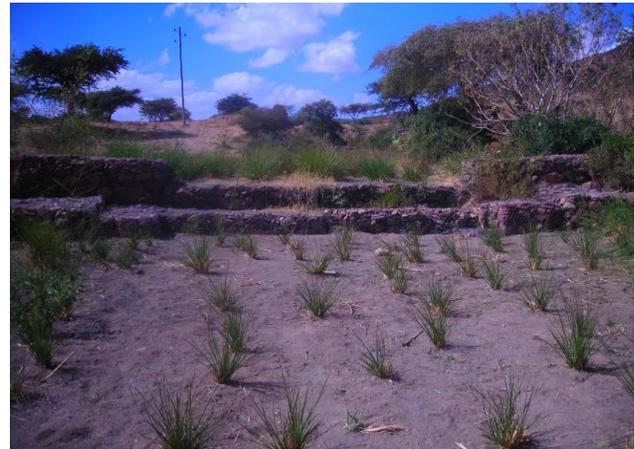
The photo was taken in January 2009  
Photo taken in Dec. 2011

b) *Water availability:* -previously, the gully, and the surrounding land did not have any water availability. But after the gully reclamation activities are done, the community gets benefits of water inside the gully as ponds for their animals and one hand pump for the community as drinking water source respectively. These all are the results of the rain harvested at different parts of the catchment recharges the groundwater and this makes shallow the water table and easily available the water for human and animal benefits. The hand pump bellow was constructed in 2009

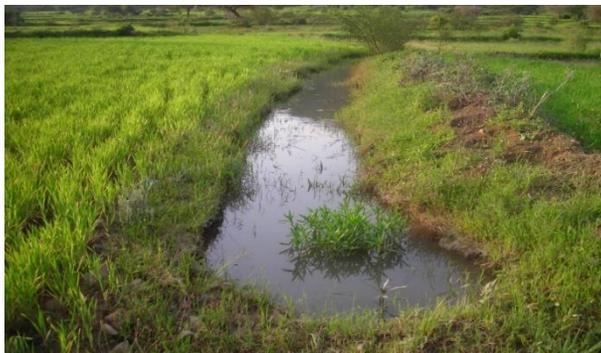
a) *Forage development:* - before the implementation of the gully reclamation, the gully was bare land or free rocky spaces. But after the implementation of these activities, different grasses like vetiver grasses, elephant grasses, and other mono plants like "Leuceania" and "Sesbania " are developed inside the gully. Hence; these all are serving as a source of forage for the animals in addition to conservation purposes.

Before the implementation of activities of the project SWC, the members of the community have no benefit from the gully. However; after the implementation of different interventions, the community's benefit is increasing from time to time. Some of the major benefits are:-

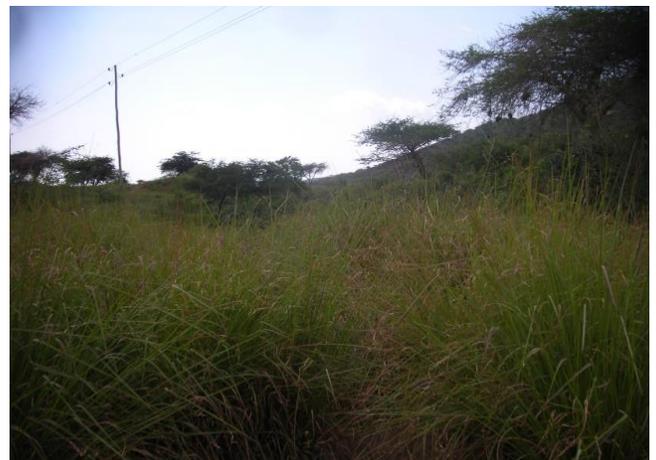
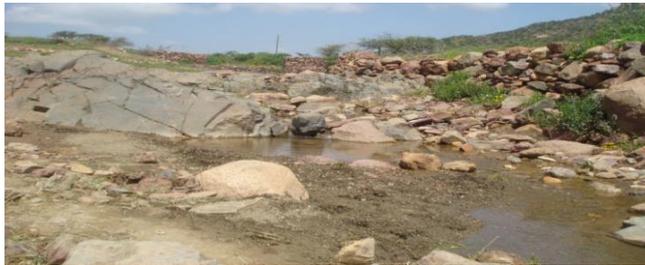
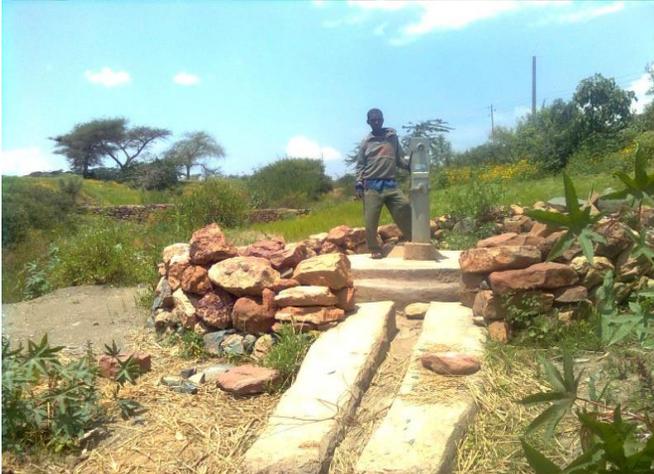
Photo of a hand pump for drinking water Photo of ponds developed & serving as a water source for cattle developed

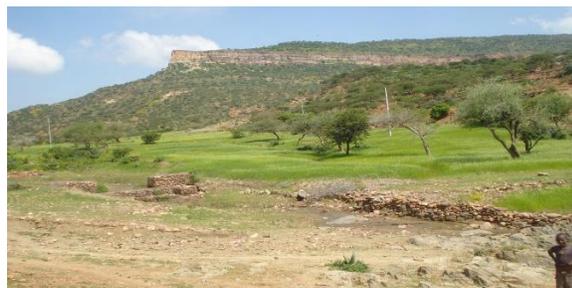
Photo of crop production statuses taken in August30/2011

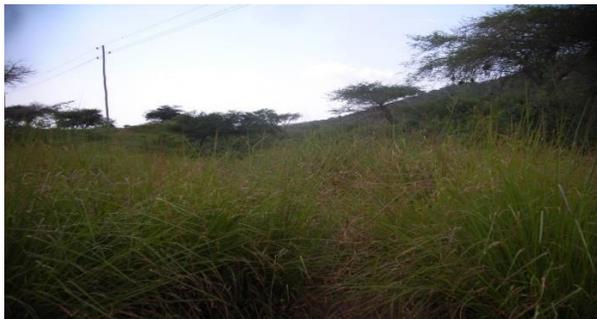
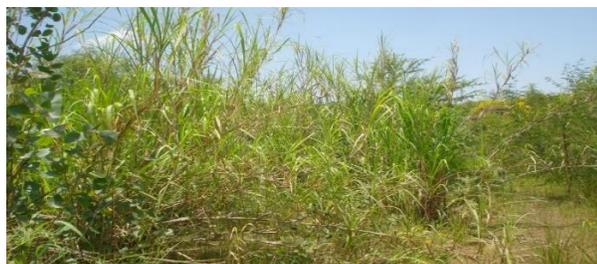
**Figure 5: The above biological treated gully used as a source of feed for livestock**

Forage grasses, shrubs, and trees have been planted and sowed to reclaim the gully (i.e. vetiver grasses, elephant grasses, S.sesban, e.t.c.). Now the community using the reclaimed gully, as a source of feed for their livestock through the cut and carries or controlled grazing system.
