# Impacts of Flood on Ekeki Housing Estate Phase 2, Yenagoa, Bayelsa State, Nigeria.

**Abstract-** Flooding Impacts on property are in varying degrees. The aim of this research is to identify the impacts of flood on Ekeki housing Estate phase 2 in Yenagoa, Bayelsa State. The philosophy adopted by the researcher was pragmatism and the research design was case study. The methods of primary data collection were through face-face interview with 2 residents within the study area and Four (4) building professionals. The research made use of purposive sampling technique for the study and the population of the study is two hundred and fifty (250 nos) housing units within the study area. The data analytic technique adopted for the study was analytic induction. The study revealed that there is lack of proper supervision and use of sub-standard building materials and lack of proper drainage system which results to extensive flood damage of water-sensitive building services and destruction of building components, thus, bringing about the deterioration of property value and consequent high cost of maintenance. Thus, the study recommended the adoption of flood resilient technologies (FREt) the

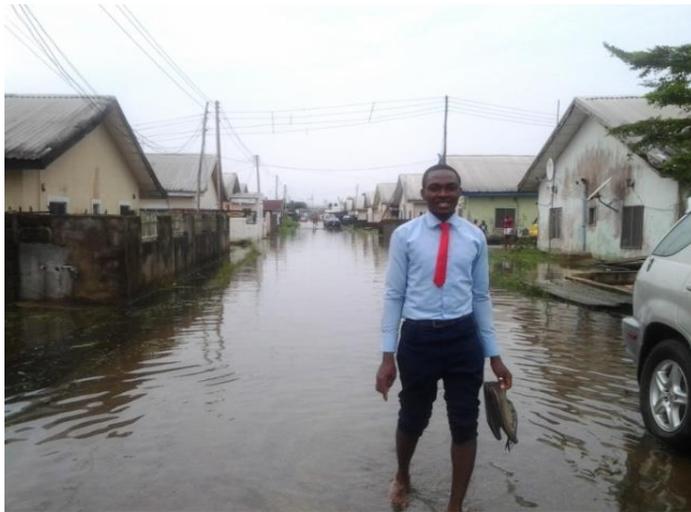
**Plate 3.1:** Picture showing inundation across street - Southern view of Road 2, Ekeki Housing Estate, Phase 2, Yenagoa (Photo taken on September 10, 2014)

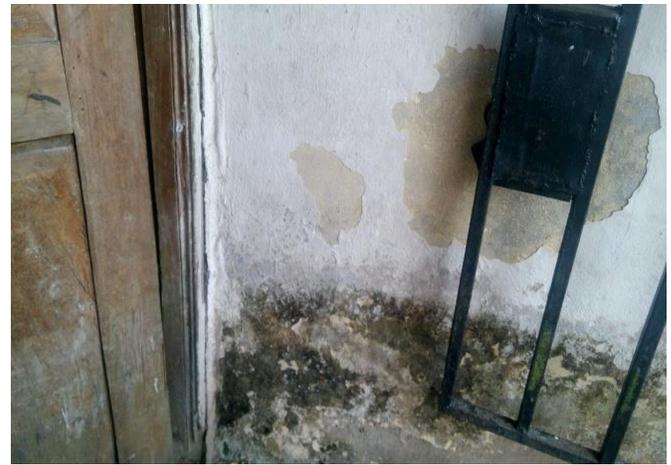
**Plate 3.2:** Picture showing decaying wooden door due to moisture and flooding on a property in study area.

Electrical shocks due to flood soaking electrical sockets and appliances. Decaying/warping of wooden doors as a result of flood soaking them.

Washing and repainting of 3Bedroom Bungalow	#200,000.00
Fumigation of surroundings against reptiles'	#10,000.00
Rendering of external & internal walls	#10,000.00
Replacement of 6 nos wooden doors @ #20,000.00 each	#120,000.00
Total costs of maintenance say	<u>#340,000.00</u>
