Investigating the Appropriateness of the Adoption of Mai Mahiu Fine Aggregate for Use in Concrete

B.O. Kambona

Department of Civil and Construction Engineering, University of Nairobi,

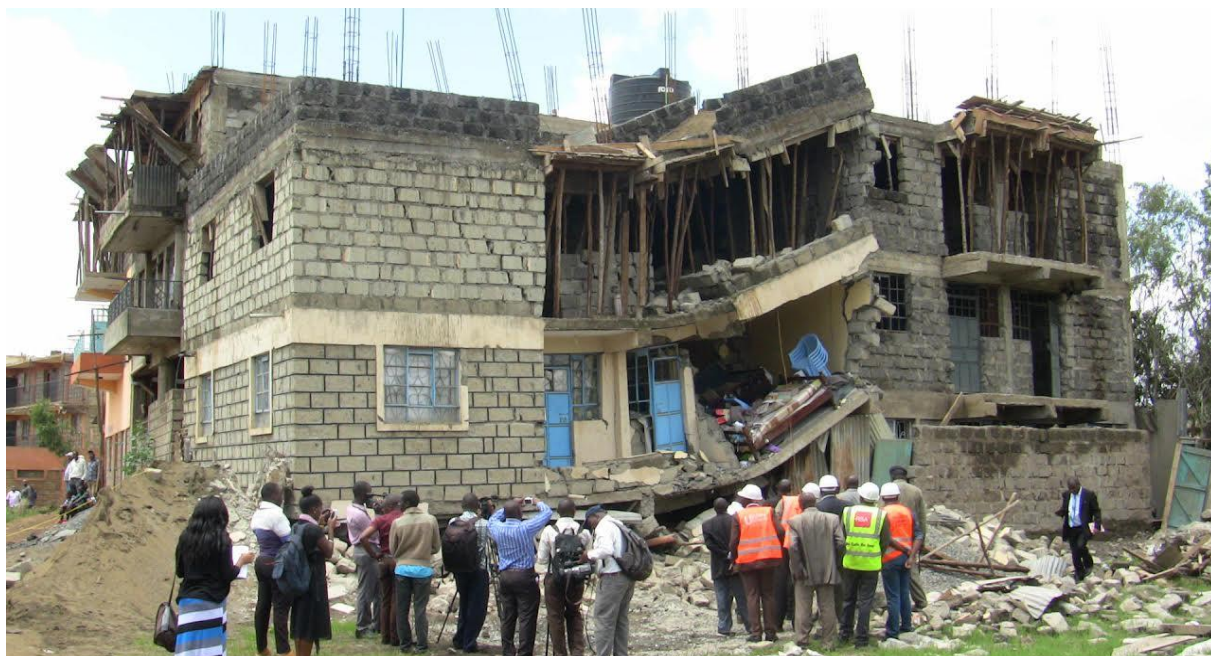
Plate 1: the debris of the building that collapsed in Kimbo area Juja Sub-County on 25th November 2016

Speaking in Kimbo, Moses Nyakiongora, the secretary of the National Buildings Inspectorate claimed that Mai Mahiu fine aggregate did not bond well to form concrete leading to the collapse in Plate 1 (www.thikatown.co.ke/2016/11/). It can be seen that people had already moved into the building. This is extremely dangerous. The fine aggregate can be seen heaped on the bottom left side of the photograph.

This study will enable understanding of the fine aggregate to avoid such conditions as illustrated in Plate 1.

Mai Mahiu fine aggregate performs very well in terms of strength and workability at zero percent silt content. In Kenya, quarry dust normally gets washed before being used in concrete. Mai Mahiu fine aggregate should also receive a similar treatment before being used in producing concrete to avoid incidents as the one shown in Plate 1 where a building collapsed.

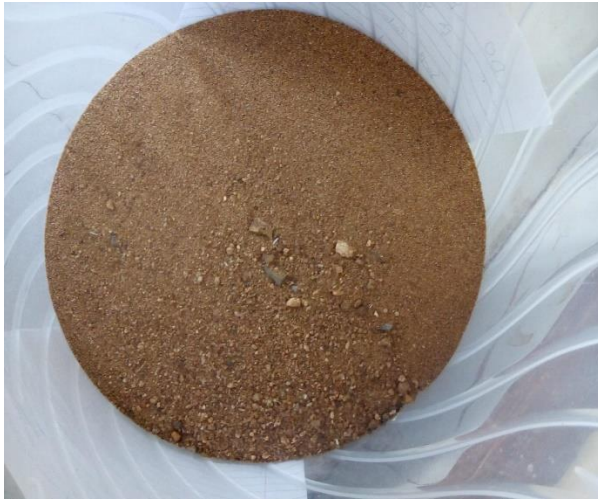
Plate 2 : River Sand without Silt and Fine Dust

Variation of the silt content was achieved by complete removal of silt through sieving over BS sieve No.200 with an aperture size of 75microns. BS sieve No.16 with an aperture size of 1.19mm was used as a nesting guard to protect the sieve No.200 from damage.

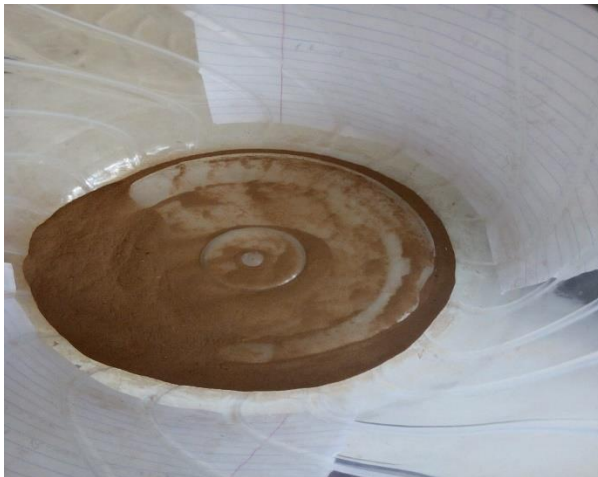
Plate 3 : Silt and Fine Dust Extracted from River Sand

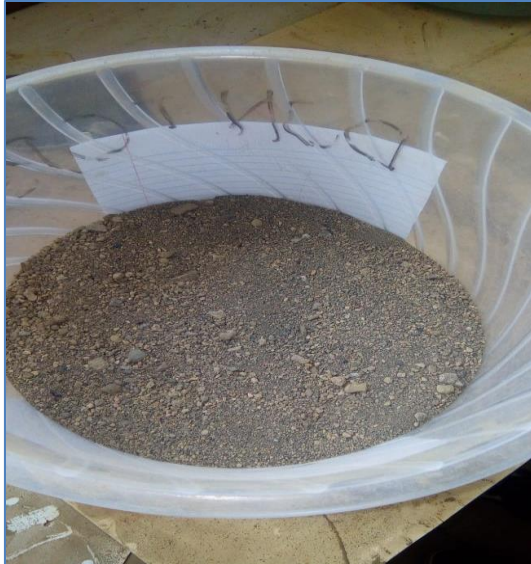
Plate 4 : Mai Mahiu Fine Aggregate without Silt and Fine Dust

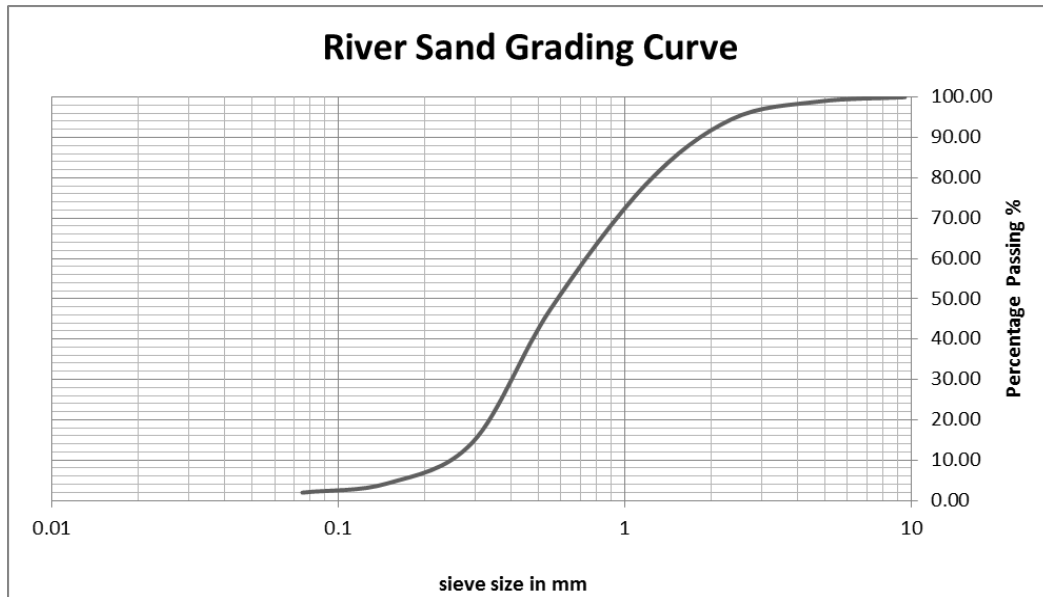
Figure 1: Grading Curve for River Sand

This is the case with the sample of river sand used in this study, from the sieve analysis 52.63% is above 600microns while 47.37% is below this value.

The percentage of silt and fine dust in the sample of river sand is 1.95%.

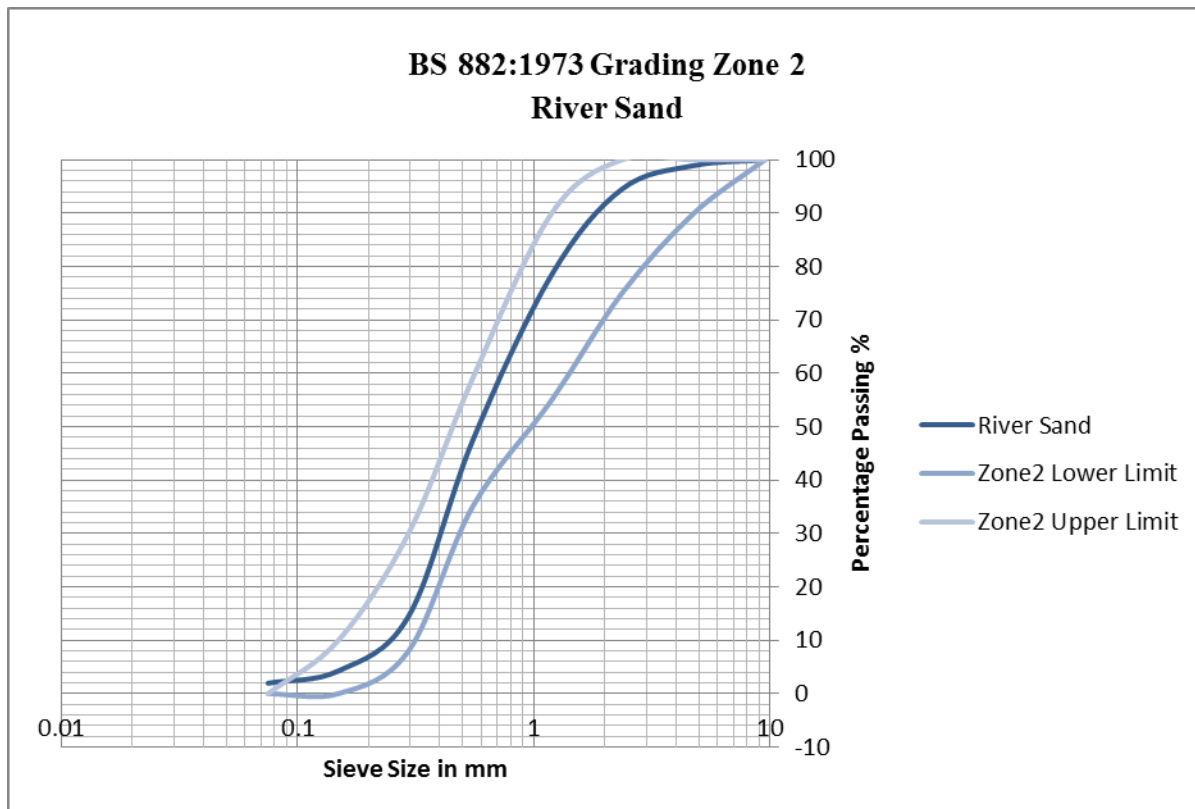
Figure 2 : River Sand Falling within Zone 2 of BS 882:1973

The river sand used in the experiment falls within Zone 2; it represents medium sand generally suitable for the standard one to two ratio of fine and coarse aggregate when the maximum size of aggregate is 20mm (Neville, 1981).
